CT Property Inspections, LLC

Property Inspection Report

41 Any Name Lane, West Hartford, CT 06107
Inspection prepared for: Jim Jones & Jane Jones
Real Estate Agent: Joe Rock - XYZ Real Estate Company

Date of Inspection: 7/27/2017 Time: 8:00 am
Age of Home: 1961 Size: 160
Weather: Sunny 78 degrees

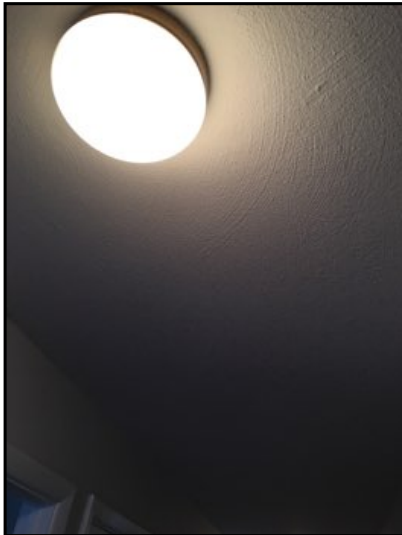
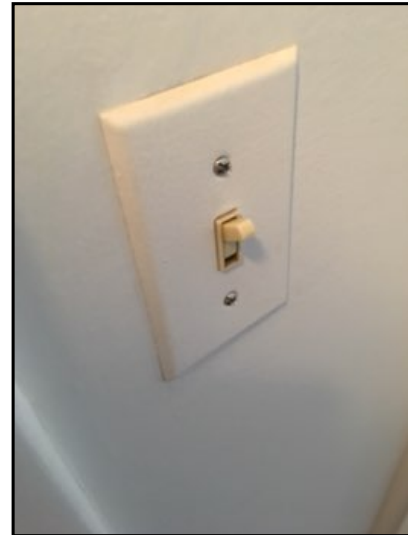
Observations:
 • Some outlets not accessible due to furniture and or stored personal items.
 • 2-prong outlets -
 The home contained outdated, ungrounded 2-prong electrical outlets. Although this condition may have been commonly considered safe or acceptable at the time the home was originally constructed, as general knowledge of safe building practices has improved with the passage of time, building standards have changed to reflect current understanding. Consider updating the existing condition to meet generally-accepted current standards.
 • Hallway 3-way switch not working properly, have a licensed electrician evaluate and repair.

3 way switch not working properly

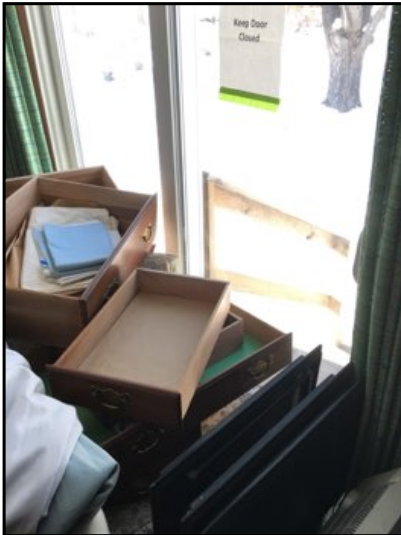
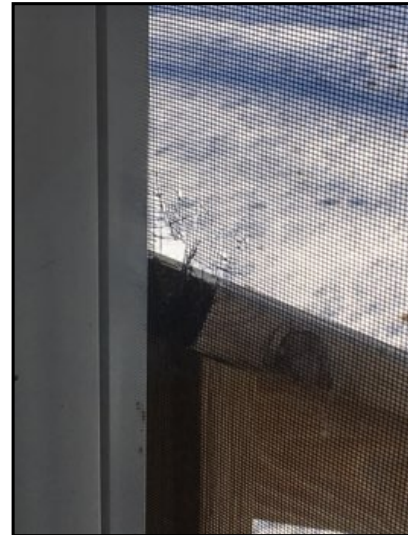
Observations:
 • Tear in patio screen door

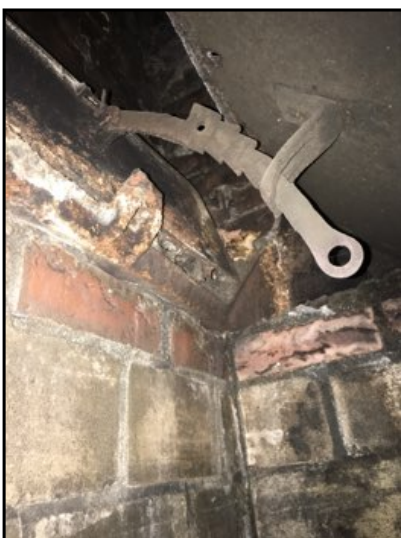
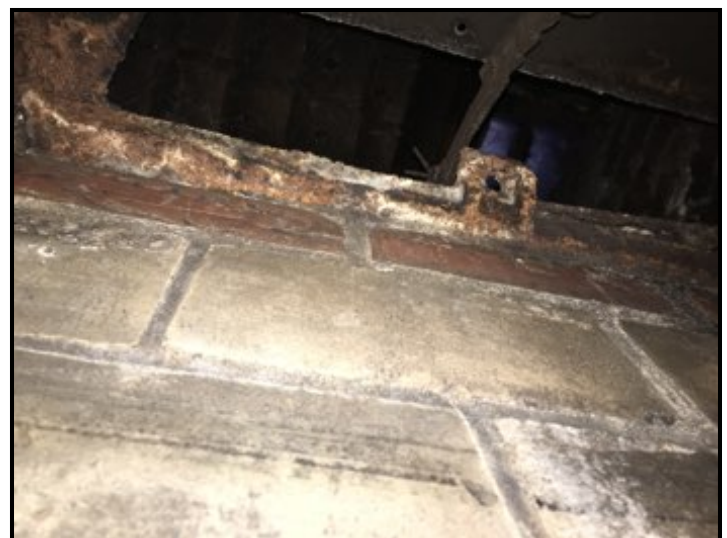
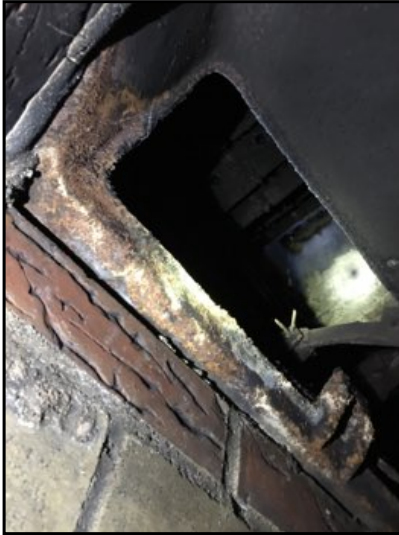
Leaves and debris in chimney

Observations:
 • Have chimneys swept by professional.
 • Level II inspection—The National Fire Protection Association (www.nfpa.org) advises that each chimney receive a Level II inspection each time a residence is sold. Inspection levels are explained at www.csia.org/pressroom/press-inspection-levels-explained.htm. It is also advised that this inspection be conducted by a chimney sweep certified by the Chimney Safety Institute of America (www.csia.org).

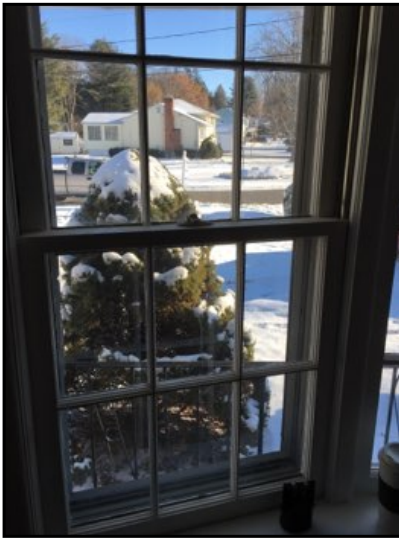
- Missing screens observed at living room windows.

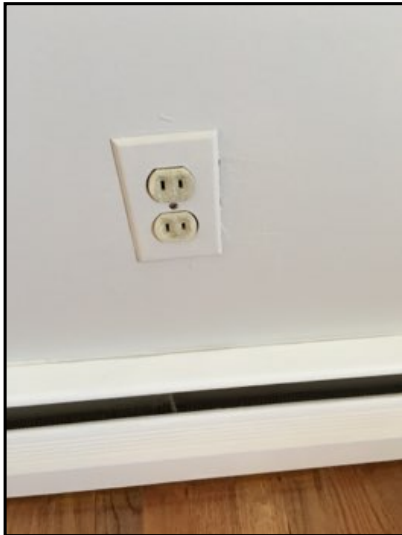
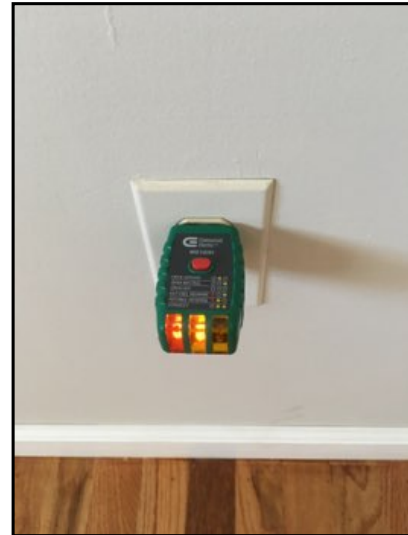
- Recommend full review by qualified electrical contractor for quotes on upgrades/repair to ensure safe and adequate service.
- Reversed polarity, hot and neutral reversed and other terms used for electric receptacles are usually easily corrected by minor wiring adjustments at the specified item. When these conditions are noted in this report, a licensed electrician should be consulted for repairs/replacement as needed to ensure safety.

Reverse Polarity

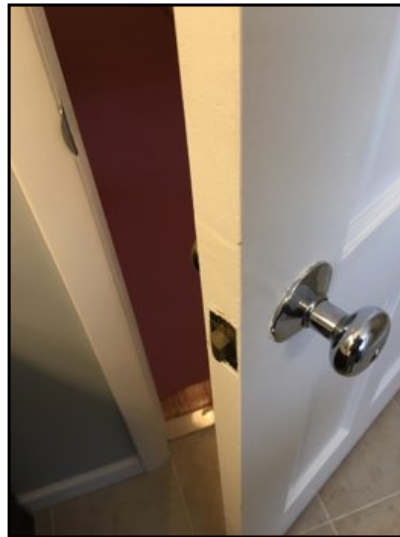
Observations:
• Door doesn't latch properly.

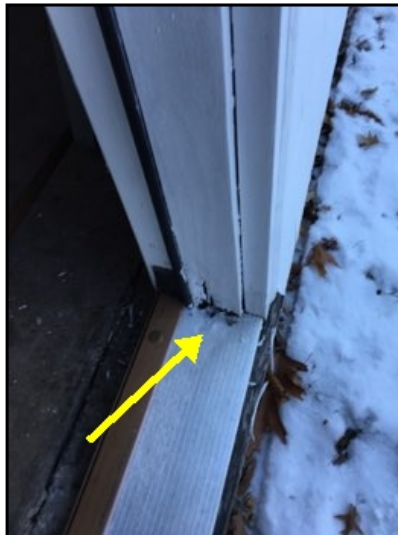
- Rot at lower sections of door frame

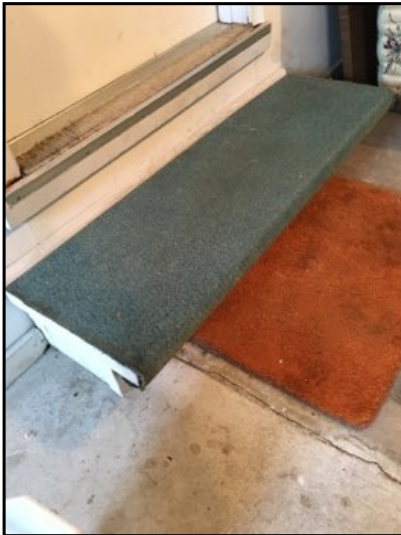
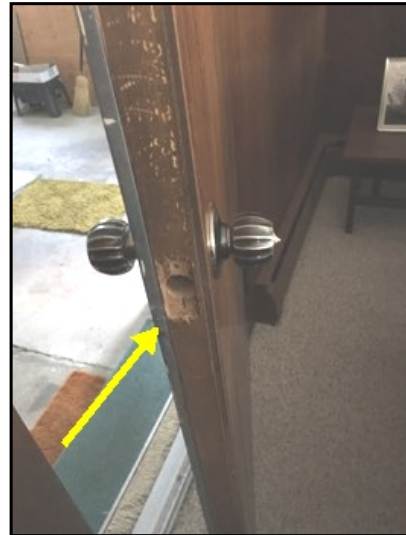
- Garage-house door does not close automatically. This is to act as a fire stop, and keeps exhaust fumes out.
- Garage door is missing locking hardware

Step is unstable leading from garage to interior

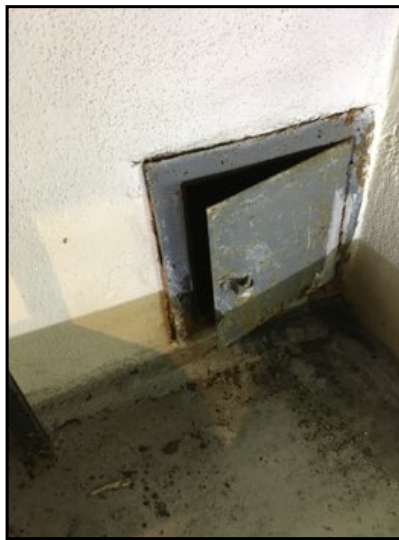
- No chimney cap visible from inspection level. Recommend installation to prevent premature weathering, water intrusion, and nesting of wildlife.
- Chimney clean-out door located in basement will not close, recommend for this to be repaired.

Clean out door will not stay closed

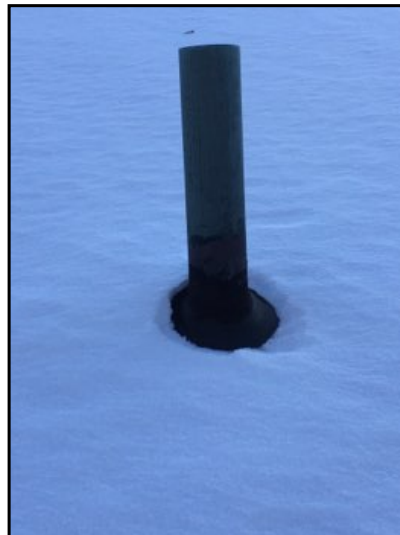
- The vent cap is missing. We recommend replacing the vent cap.

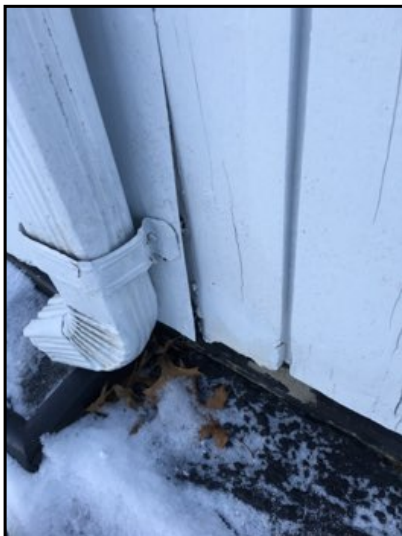
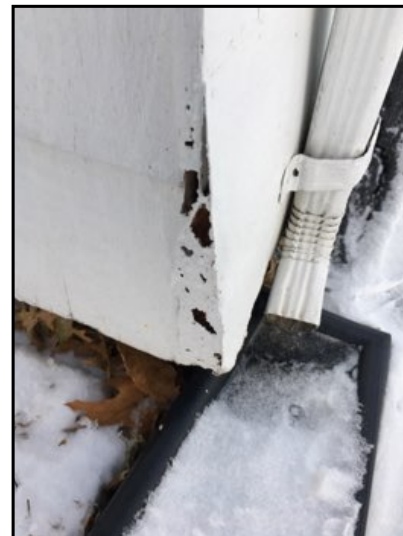
- Extensions / Splash blocks missing or insufficient: Install to divert water away from the foundation.
- Maintenance Tip: Keep gutters cleared of organic debris to prevent downspouts from being clogged causing overflow at gutters, ensure that all downspouts have extensions/splash blocks to carry water away from the foundation and ensure that sprinkler system does not spray siding or windows of house.
- Some downspouts are falling from gutter and some may be too close to ground. Suggest raising downspouts 6-8" above grade

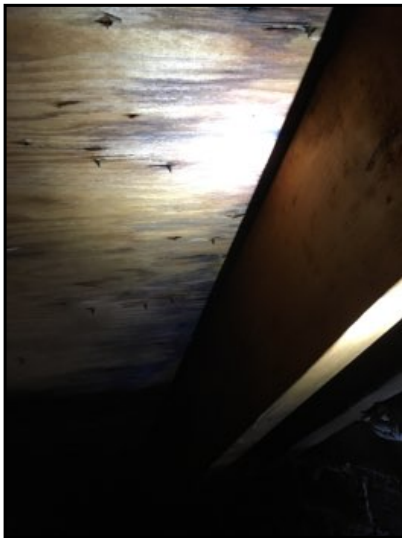
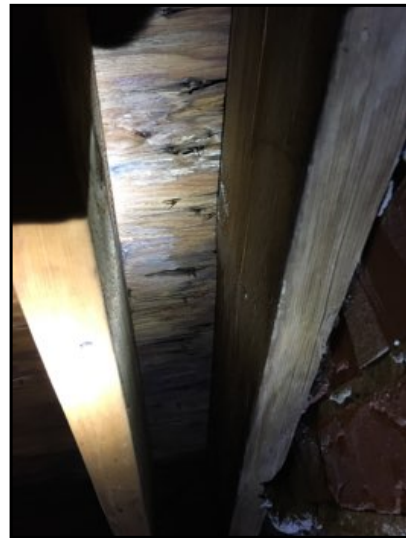
- Evidence of past or present leaks, dry at time of the inspection. Monitor for leaks &/or have roofing contractor evaluate.

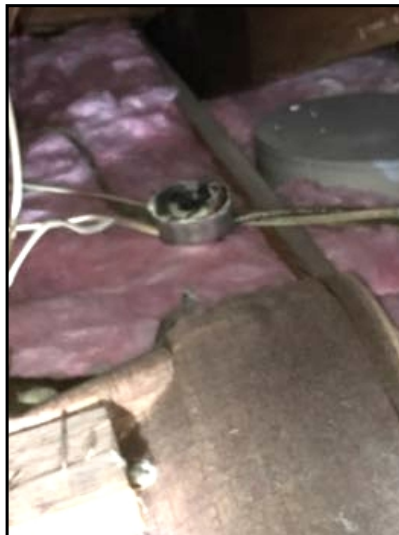
- Open junction boxes were observed, which is a safety concern. Recommend installing proper covers, as needed, for safety.

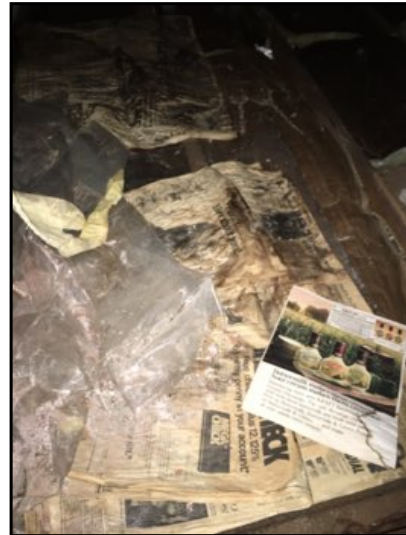
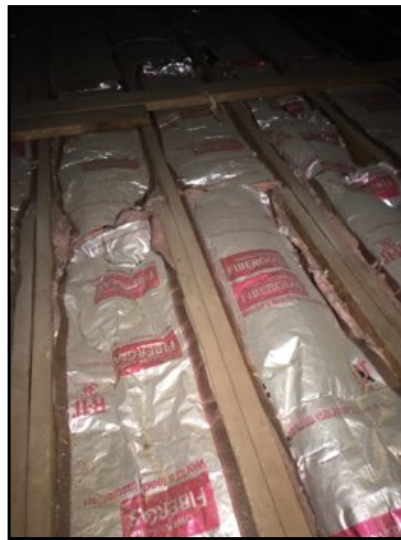
Depth: Insulation averages 3 to 4 inches. Recommend installing more.

- Insulation that is settled does not perform to the R-Value that it once did.

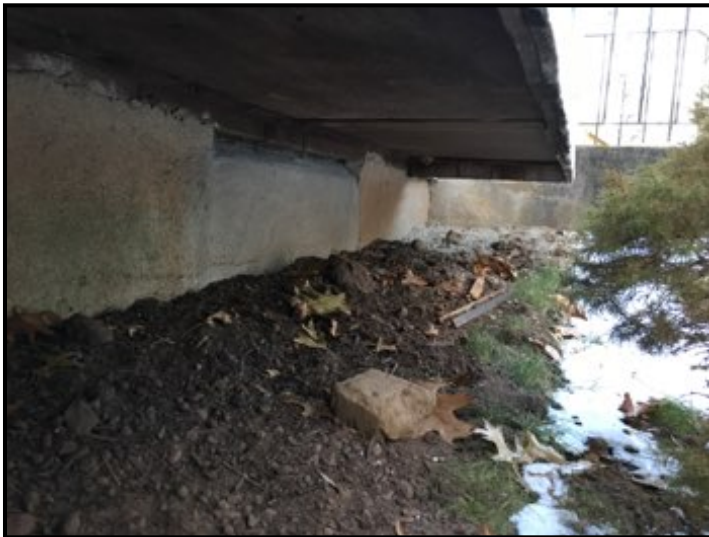
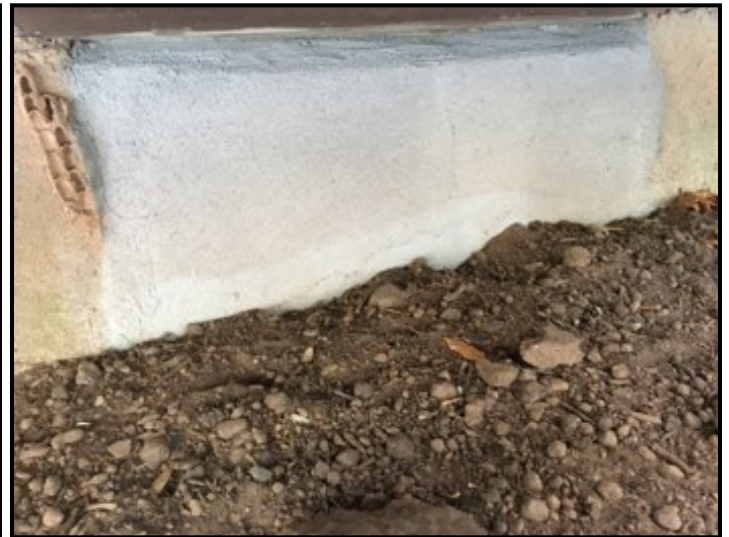
- Basement windows have been removed and filled with cement.

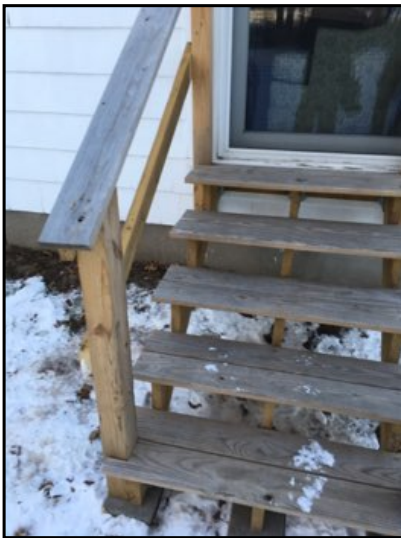
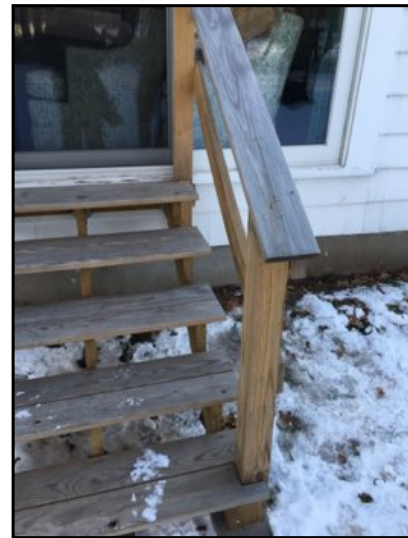
Observations:
 • Railings leading out from patio door are slightly loose

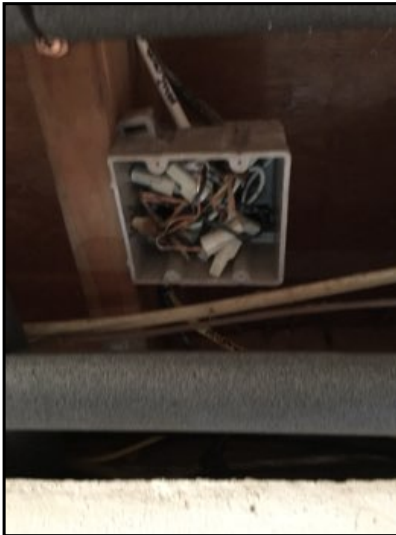
- **Open junction box was observed, which is a safety concern. Recommend installing proper covers, as needed, for safety.**

Missing cover

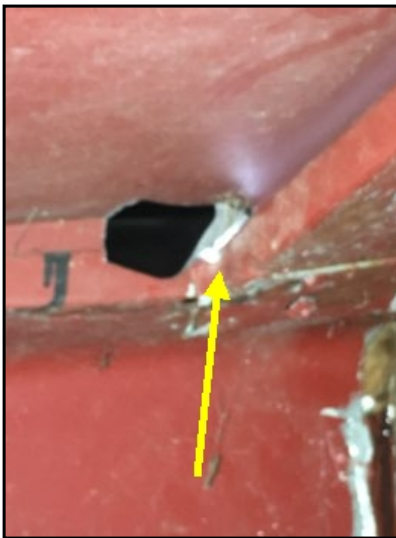
Materials: Exterior bulkhead had signs of previous repair, suggest monitoring after rain events.

- Exterior entrance is in serviceable condition.
- Bulk head has a hole, refer to picture. Was covered with utility tape.

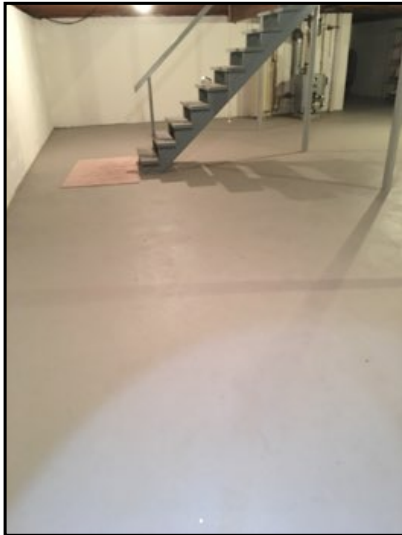
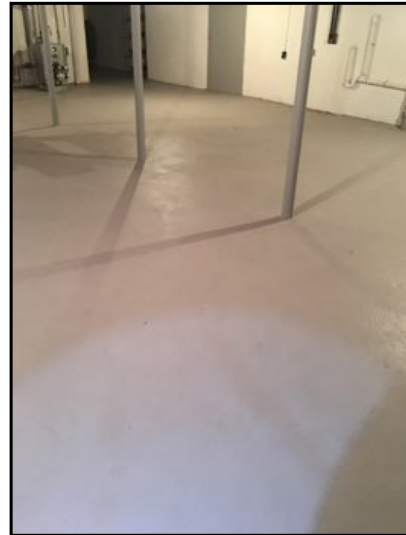
- Observations:
- Common cracks noted.
 - Floor has been painted.
